Technical Appendix 8.5: Schedule of Watercourse Crossings

Breezy Hill Wind Farm

Breezy Hill Energy Ltd

10 March 2025

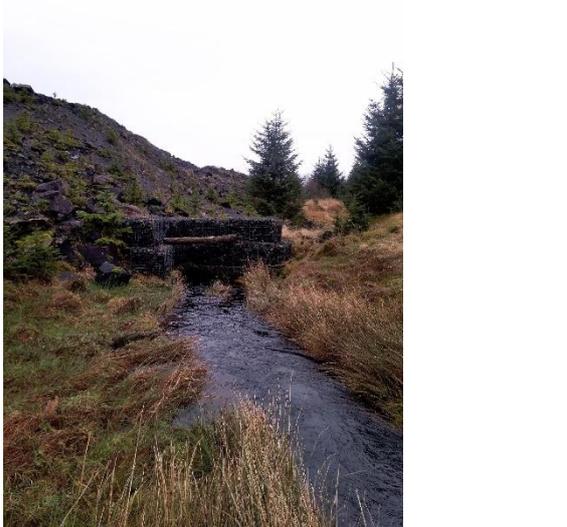
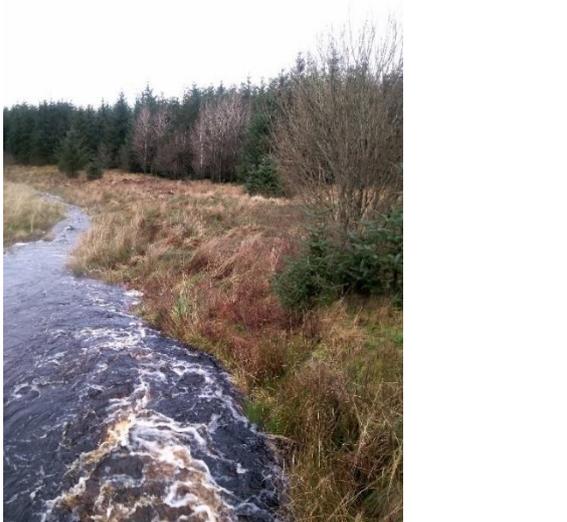
Watercourse Crossing ID	WCX01
Watercourse Crossing Details	<p>Grid Reference: E 248771/ N 611763</p> <p>Status: Existing</p> <p>Crossing Type: Closed culvert</p> <p>Crossing Size: 1.0 m diameter</p> <p>Watercourse Width: 2.0 m</p> <p>Watercourse Depth: 0.7 m</p> <p>Notes: None</p>
Photograph Culvert Entrance

Photograph Looking Downstream

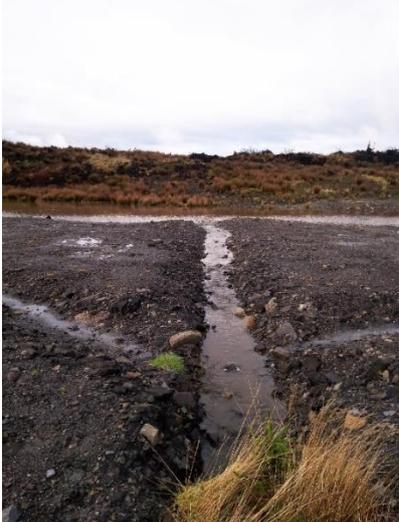
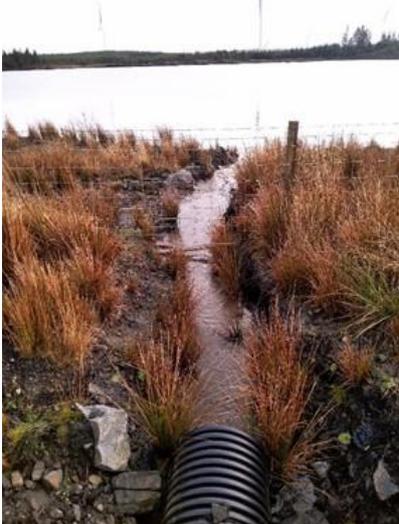
Watercourse Crossing ID	WCX02
Watercourse Crossing Details	<p>Grid Reference: E 248118 / N 611530</p> <p>Status: Existing</p> <p>Crossing Type: Closed culvert</p> <p>Crossing Size: 0.4 m diameter</p> <p>Watercourse Width: 0.8 m</p> <p>Watercourse Depth: 0.4 m</p> <p>Notes: Artificial drain connecting two artificial surface waterbodies.</p>
Photograph Looking Upstream

Photograph Culvert Exit Looking Downstream

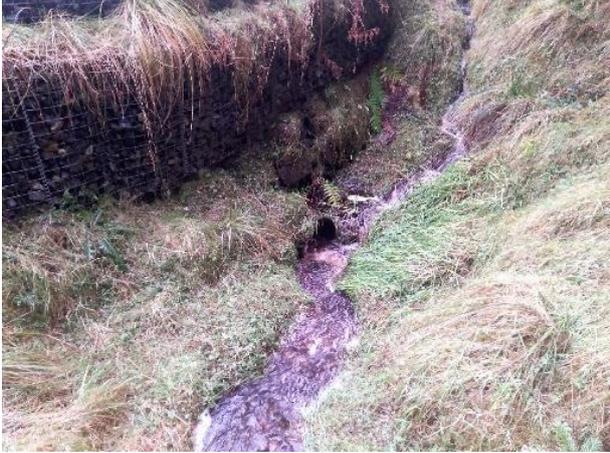
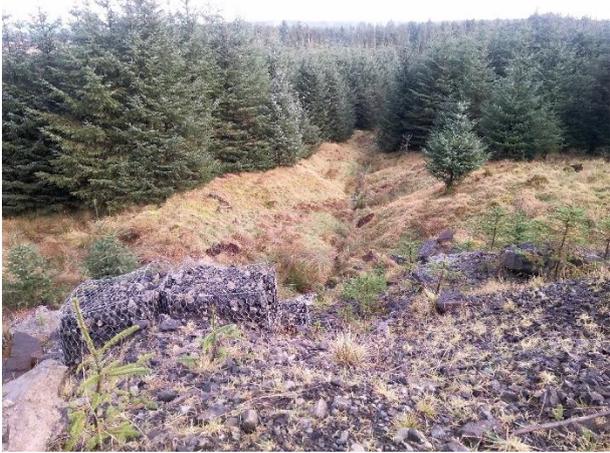
Watercourse Crossing ID	WCX03
Watercourse Crossing Details	<p>Grid Reference: E 247355 / N 611658</p> <p>Status: Existing</p> <p>Crossing Type: Closed culvert</p> <p>Crossing Size: 0.4 m diameter</p> <p>Watercourse Width: 0.6 m</p> <p>Watercourse Depth: 0.1 m</p> <p>Notes: None.</p>
Photograph Culvert Entrance

Photograph Looking Downstream

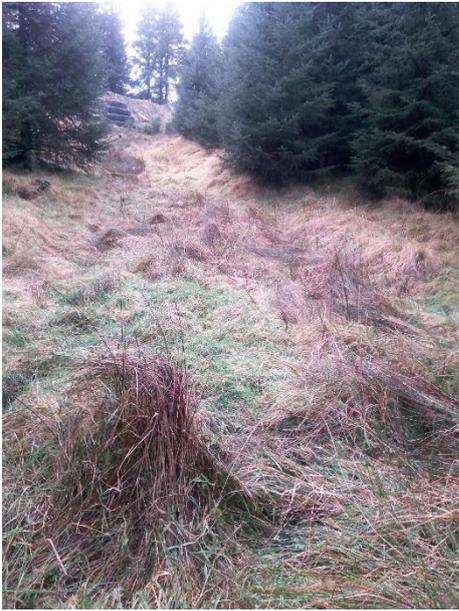
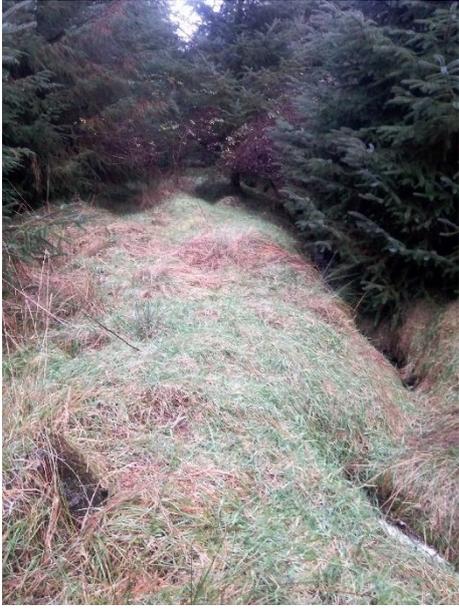
Watercourse Crossing ID	WCX04
Watercourse Crossing Details	<p>Grid Reference: E 247417 / N 611705</p> <p>Status: New</p> <p>Watercourse Width: 1 m</p> <p>Watercourse Depth: 0.7 m</p> <p>Notes: Watercourse located in forestry ride. Water level noted to be medium, with high flow, and orange colour.</p>
Photograph Looking Upstream

Photograph Looking Downstream

Potential Crossing Type Likely Required CAR Authorisation	Culvert Registration

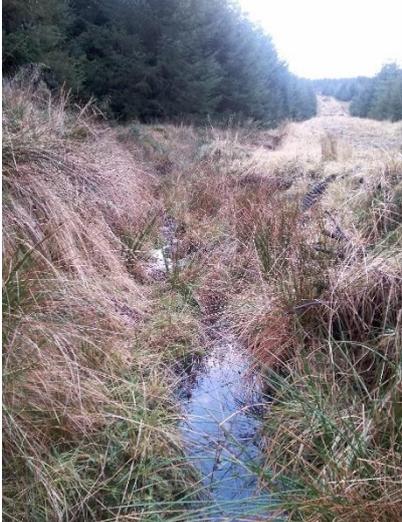
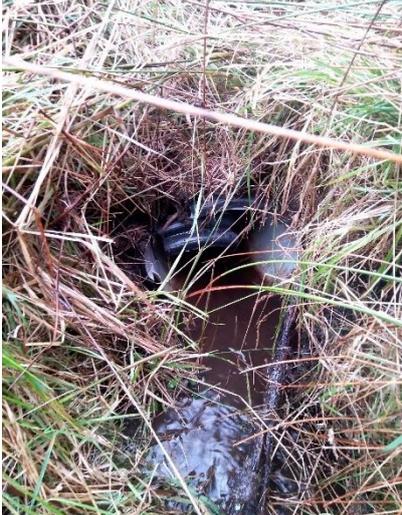
Watercourse Crossing ID	WCX05
Watercourse Crossing Details	<p>Grid Reference: E 247442 / N 611920</p> <p>Status: Existing</p> <p>Crossing Type: Closed culvert</p> <p>Crossing Size: 0.2 m diameter</p> <p>Watercourse Width: 0.2 m</p> <p>Watercourse Depth: 0.1 m</p> <p>Notes: Watercourse noted to be artificially modified upslope by forestry.</p>
Photograph Looking Upstream

A photograph showing a narrow watercourse flowing through a field of tall, dry grass. The water is dark and reflects the sky. The background shows a line of trees under a bright sky.
Photograph Culvert Exit

A close-up photograph of a culvert exit. The culvert is a dark, circular opening in the ground, surrounded by tall, dry grass. The water is dark and appears to be flowing out of the culvert.

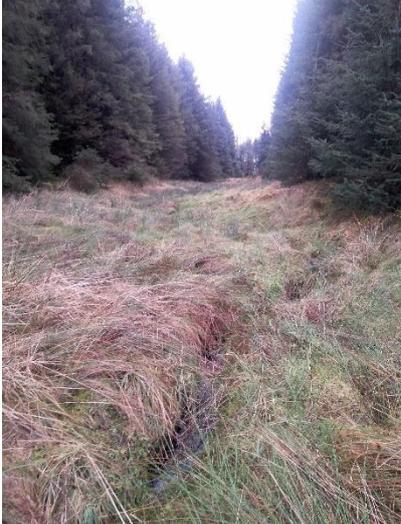
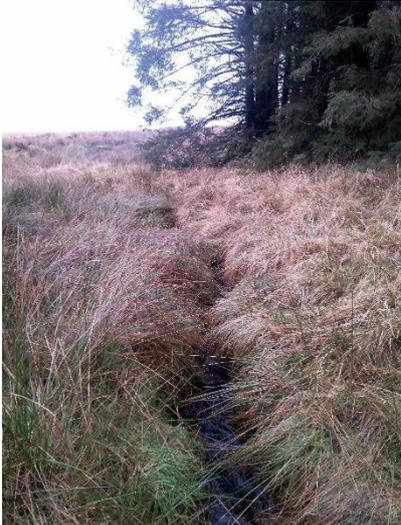
Watercourse Crossing ID	WCX06
Watercourse Crossing Details	<p>Grid Reference: E 247501 / N 612011 Status: New Watercourse Width: 0.4 m Watercourse Depth: 0.4 m Notes: Watercourse monitored approx. 20 m upstream during survey.</p>
Photograph Looking Upstream

Photograph Looking Downstream

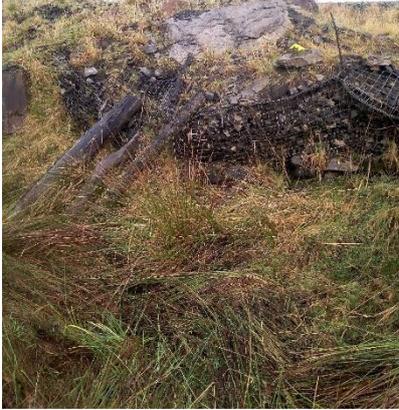
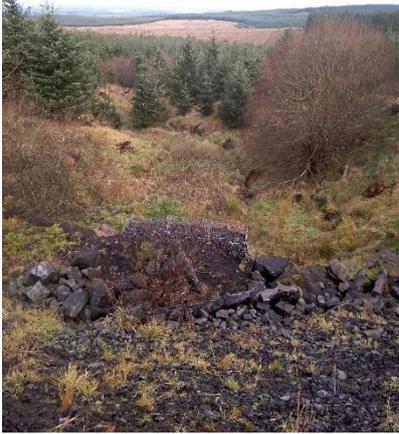
Watercourse Crossing ID	WCX07
Watercourse Crossing Details	<p>Grid Reference: E 247284 / N 611695</p> <p>Status: Existing</p> <p>Notes: Culvert present was hidden due to collapsed gabion stone and overgrown vegetation.</p>
Photograph Looking Upstream

Photograph Looking Downstream

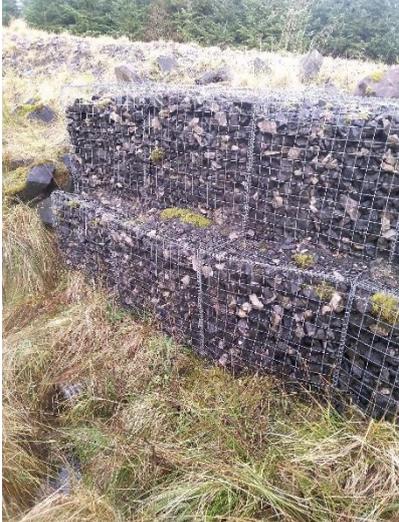
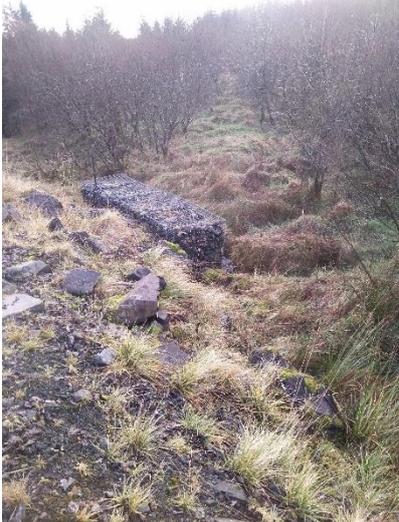
Watercourse Crossing ID	WCX08
Watercourse Crossing Details	<p>Grid Reference: E 247188 / N 611730</p> <p>Status: Existing</p> <p>Crossing Type: Closed culvert</p> <p>Crossing Size: 0.3 m diameter</p> <p>Watercourse Width: 0.35 m</p> <p>Watercourse Depth: 0.1 m</p> <p>Notes: Culvert hidden by vegetation.</p>
Photograph Culvert Entrance

Photograph Looking Downstream

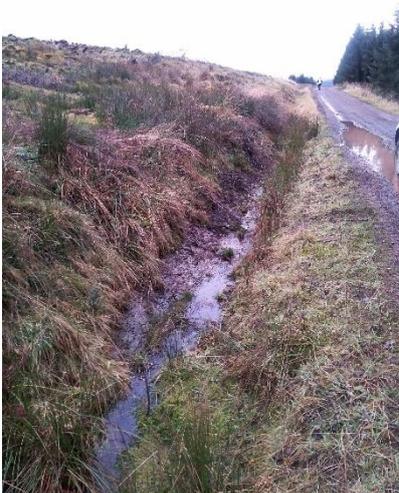
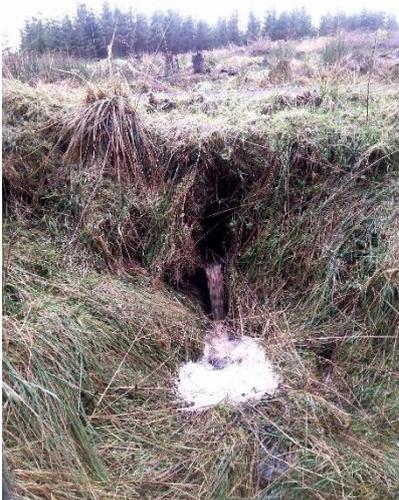
Watercourse Crossing ID	WCX09
Watercourse Crossing Details	<p>Grid Reference: E 248719 / N 612252</p> <p>Status: Existing</p> <p>Crossing Type: Closed culvert</p> <p>Crossing Size: 0.3 m diameter</p> <p>Watercourse Width: 0.5 m</p> <p>Watercourse Depth: 0.3 m</p> <p>Notes: Culvert is utilised for trackside drainage.</p>
Photograph Looking Upstream

Photograph Culvert Exit

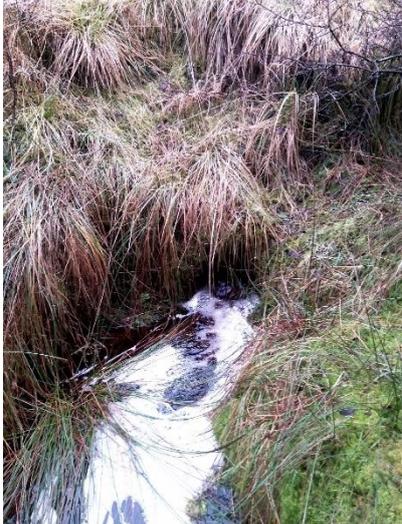
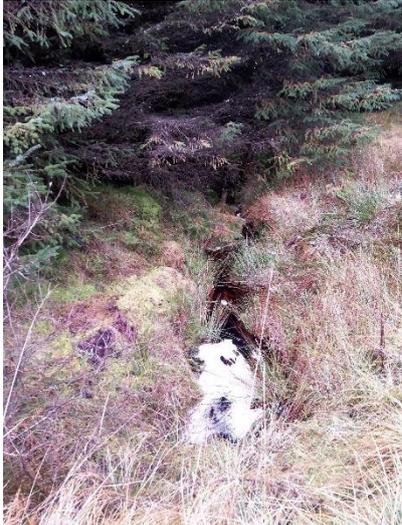
Watercourse Crossing ID	WCX10
Watercourse Crossing Details	<p>Grid Reference: E 248582 / N 612488</p> <p>Status: Existing</p> <p>Crossing Type: Closed culvert</p> <p>Crossing Size: 0.3 m diameter</p> <p>Watercourse Width: 0.7 m</p> <p>Watercourse Depth: 0.2 m</p> <p>Notes: None.</p>
Photograph Culvert Entrance

Photograph Looking Downstream

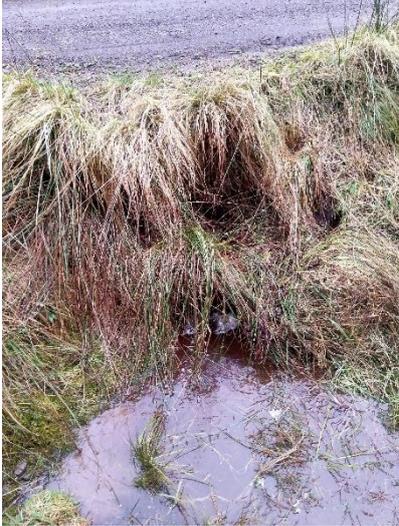
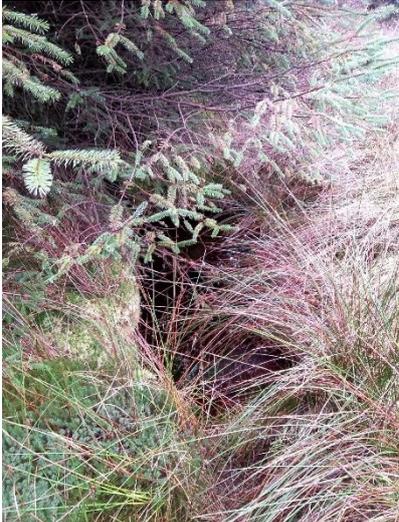
Watercourse Crossing ID	WCX11
Watercourse Crossing Details	<p>Grid Reference: E 248577 / N 612505 Status: Existing Crossing Type: Closed culvert Crossing Size: 0.2 m diameter Notes: None.</p>
Photograph Looking Upstream

Photograph Looking Downstream

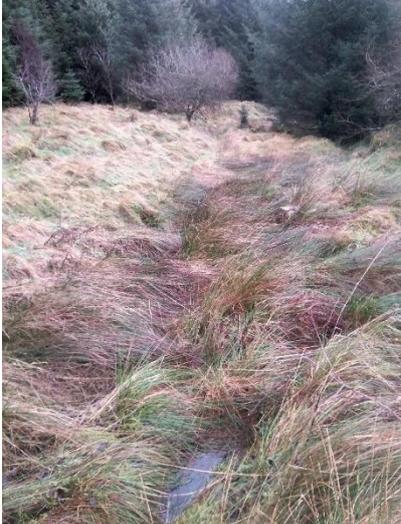
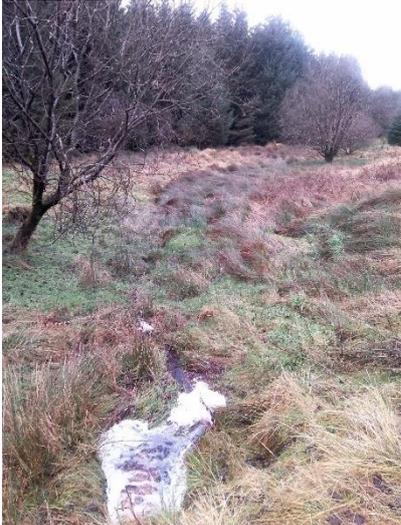
Watercourse Crossing ID	WCX12
Watercourse Crossing Details	<p>Grid Reference: E 248288 / N 613229</p> <p>Status: Existing</p> <p>Crossing Type: Closed culvert</p> <p>Crossing Size: 0.4 m diameter</p> <p>Watercourse Width: 0.5 m</p> <p>Watercourse Depth: 0.2 m</p> <p>Notes: None.</p>
Photograph Looking Upstream

Photograph Looking Downstream

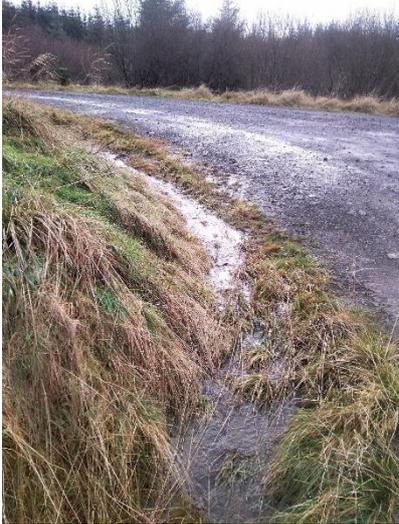
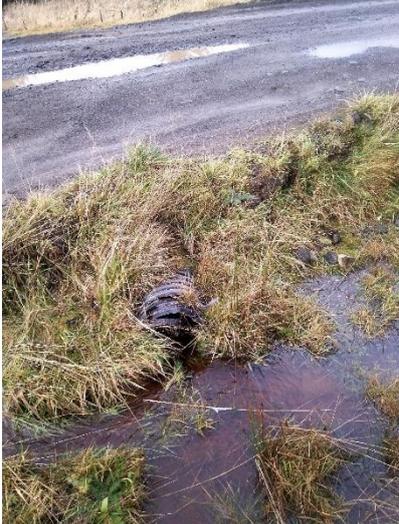
Watercourse Crossing ID	WCX13
Watercourse Crossing Details	<p>Grid Reference: E 248231 / N 613530</p> <p>Status: Existing</p> <p>Crossing Type: Closed culvert</p> <p>Crossing Size: 0.3 m diameter</p> <p>Watercourse Width: 0.8 m</p> <p>Watercourse Depth: 0.05 m</p> <p>Notes: None.</p>
Photograph Looking Upstream

A photograph showing a gravel road crossing a watercourse. The water is flowing through a narrow channel in the gravel, surrounded by tall grasses and a line of trees in the background.
Photograph Looking Downstream

A photograph showing a culvert structure under a gravel road. The water is flowing through the culvert, and there is a small pool of water in the foreground. The surrounding area is covered in tall grasses.

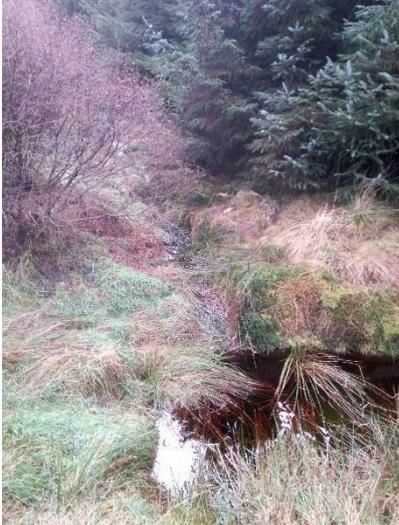
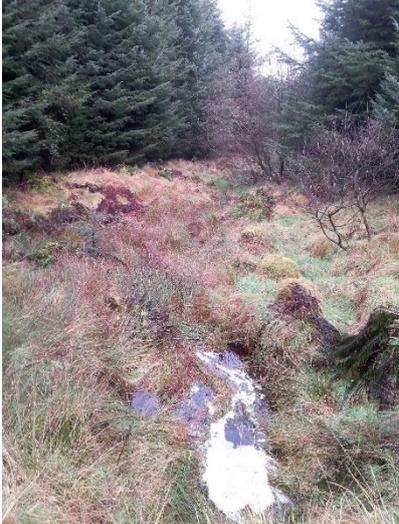
Watercourse Crossing ID	WCX14
Watercourse Crossing Details	<p>Grid Reference: E 248538 / N 613467</p> <p>Status: Existing</p> <p>Crossing Type: Closed culvert</p> <p>Crossing Size: 0.3 m diameter</p> <p>Watercourse Width: 0.6 m</p> <p>Watercourse Depth: 0.09 m</p> <p>Notes: Culvert covered by vegetation and water pooling upstream.</p>
Photograph Looking Upstream

A photograph showing a watercourse crossing from an upstream perspective. The crossing is a small, circular culvert partially obscured by tall, dry grasses and other vegetation. The water is pooling in a small depression just upstream of the crossing. The background consists of a dense forest of evergreen trees.
Photograph Looking Downstream

A photograph showing a watercourse crossing from a downstream perspective. The crossing is a small, circular culvert partially obscured by tall, dry grasses and other vegetation. The water is pooling in a small depression just downstream of the crossing. The background consists of a dense forest of evergreen trees.

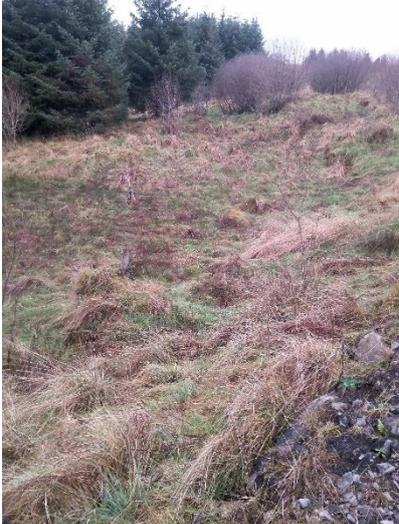
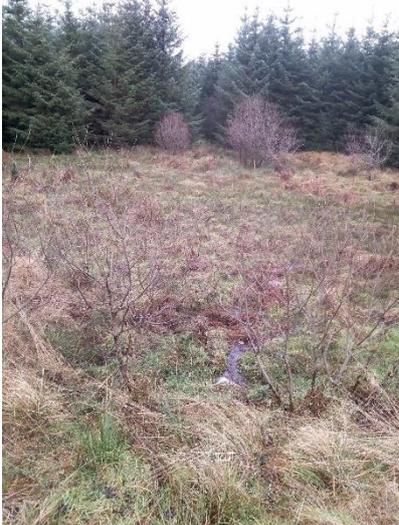
Watercourse Crossing ID	WCX15
Watercourse Crossing Details	<p>Grid Reference: E 248629 / N 613363</p> <p>Status: Existing</p> <p>Crossing Type: Closed culvert</p> <p>Crossing Size: 0.5 m diameter</p> <p>Watercourse Width: 0.3 m</p> <p>Watercourse Depth: 0.2 m</p> <p>Notes: None.</p>
Photograph Looking Upstream

Photograph Looking Downstream
