Technical Appendix 8.3 Peat Landslide Hazard and Risk Assessment

Breezy Hill Energy Project

Breezy Hill Energy Limited

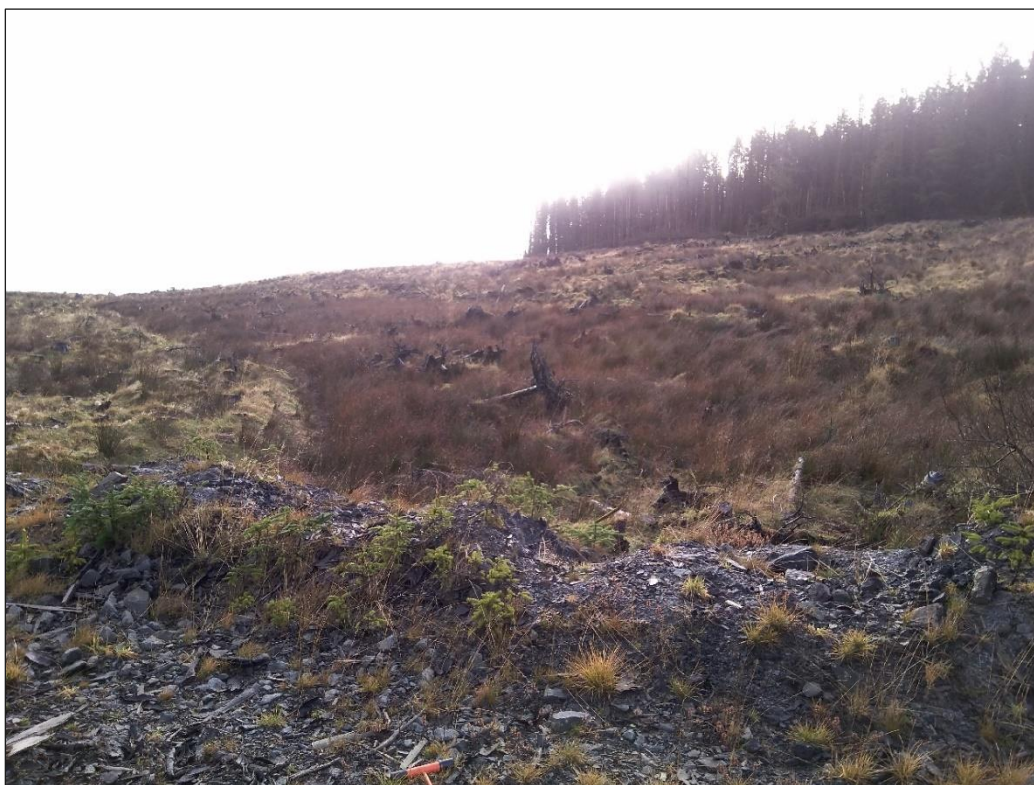
Photograph 3-1 Commercial Forestry

The Proposed Development is set primarily within commercial forestry (**Photograph 3-1**), with small areas of open moorland (**Photograph 3-2**). Historic land use onsite includes opencast mining, with artificial modified surface waterbodies present. The elevation on-site slopes from 420 m Above Ordnance Datum (AOD) in the south of the Site to 220 m AOD in the north-west. OS Terrain 5 Digital Terrain Model (DTM) data has been used, to create a slope plan for the Site, presented in **Figure 8.3.5**.

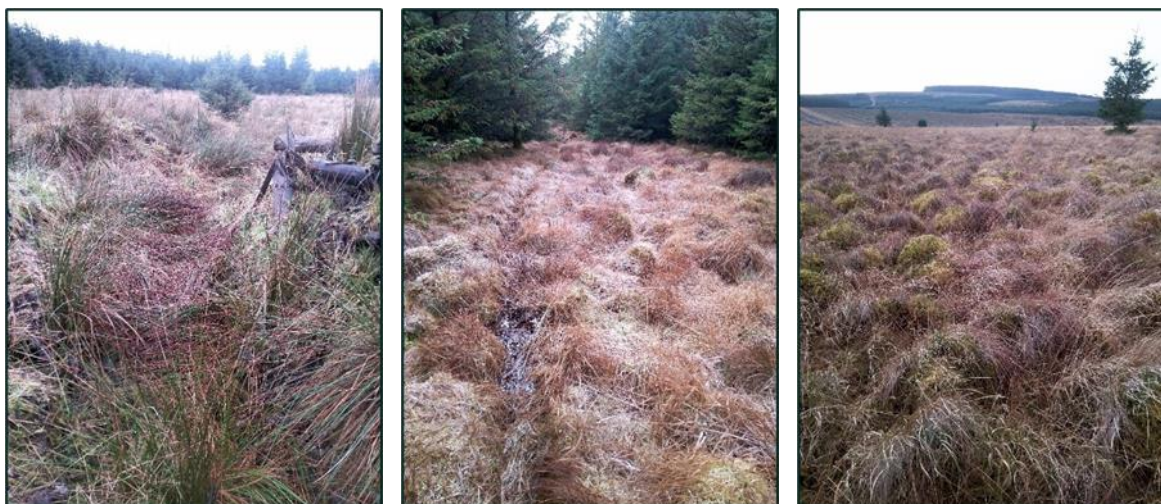
Plate 5-2 –Site ground conditions

The Proposed Development infrastructure has been through several design iterations, informed by multiple phases of peat probing. The development infrastructure has avoided areas of deep peat so far as practicable, whilst taking into consideration other technical and environmental constraints. General ground conditions of the Site area are shown in **Plate 5-2**.
