# Technical Appendix 8.3 Peatland Condition Assessment

## Dalfad Wind Farm

### Brockwell Energy Limited

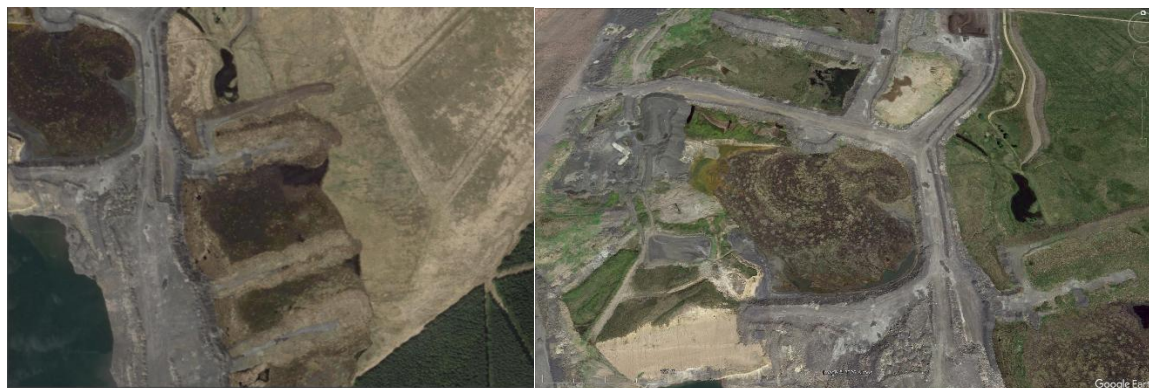
**Plate 3-1 Areas of made ground comprising mixed superficial and mining spoil**

Infrastructure on the Site is primarily associated with the legacy operations of the former Dalfad Opencast Mine. Large areas of the Site comprise made ground, reflecting extensive historic mining, surface road construction and the reworking of overburden. Made ground is present across much of the Proposed Development infrastructure and is particularly pronounced at the edges of the former excavation areas, where redeposited materials have been placed during restoration phases. In several locations, made ground has been remediated, and there is potential that peat or peat-forming materials were used in parts of the reinstatement process.

The made ground across the Site appears to be variable in composition and depth, with the potential for voids, heterogenous fill layers and uneven consolidation. Most areas have undergone some degree of reworking with only limited parts of the original landform remaining. The historical coal mining has removed and/or disturbed much of the peatland that may have been present on Site historically. Remediation of the historic mining has resulted in a number of cells and areas of made ground comprising a mix of former organic rich soils, mineral soils, mining spoil which overlie or replace much of the original soil on the site. In some areas these have led to perched water tables which have been colonised by wetland species, but which do not contain organic rich soils.

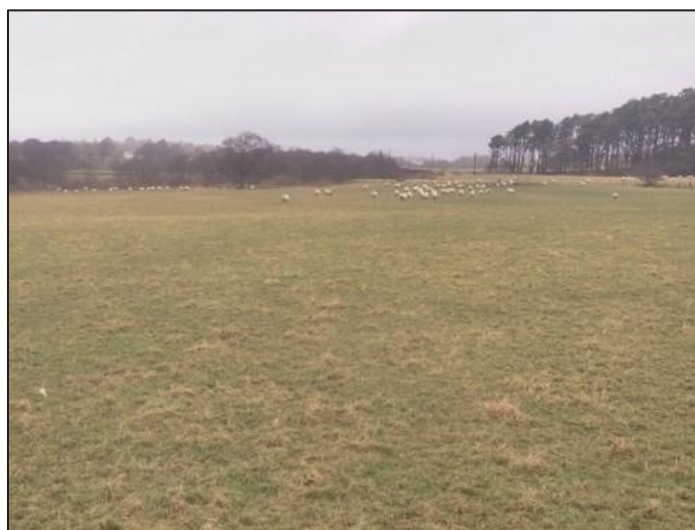
**Photograph 4-1 High grazing pressure noted across the Site, specifically in the southeast**

Field validation surveys were undertaken across the Site to verify the peatland condition and land-use characteristics identified during the desk study and aerial imagery review. The surveys confirmed that the Site is dominated by agricultural land uses, comprising a mixture of rough grazing and improved grassland, together with smaller areas of heathland, commercial forestry and land influenced by historic mining activities. Evidence of intensive grazing pressure was widespread across the Site, including extensive livestock tracks and sheep grazing activity (photograph 4-1), supporting the desk-based interpretation that agricultural management is a key influence on habitat condition in parts of the site.

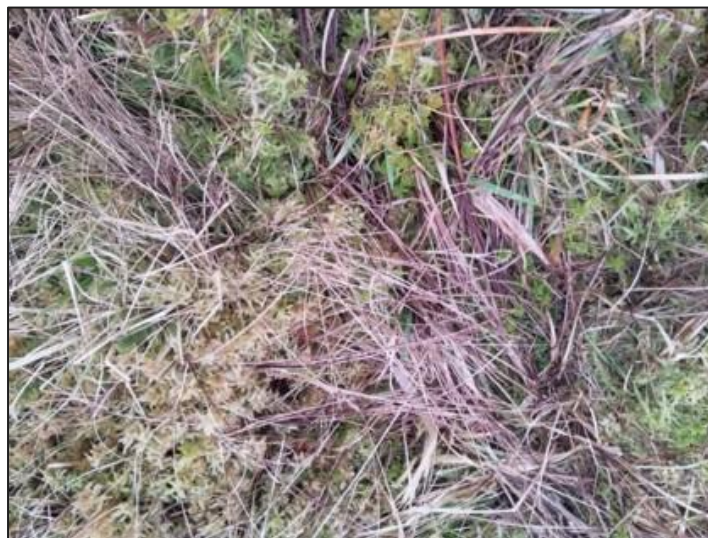
**Photograph 4-2 Sphagnum species identified within wetter areas of the modified peatland on Site**

Field observations confirmed that peat deposits are generally limited in extent and largely confined to isolated topographic depressions within the undulating glacial landscape. Peat surfaces were typically dry rather than waterlogged, indicating modified hydrological conditions and limited active peat-forming processes. Peat was also generally dense and compacted, consistent with long-term drying and grazing impacts. These findings support the desk study conclusion that the majority of peatland within the Site is in a modified condition and does not exhibit the characteristics of active or near-natural peatland.

Vegetation surveys further validated the desk-based assessment of peatland condition. Peat-forming Sphagnum mosses (Photograph 4-2) were scarce across most of the Site and largely restricted to a small number of wetter areas in the eastern extent, adjacent to more intact peatland habitats beyond the Site boundary. Where present, Sphagnum communities were generally of low diversity and comprised species associated with relatively limited peat accumulation. In contrast, non-peatland grasses were abundant across much of the Site, while characteristic peat-forming species such as cotton grass and deer grass were largely absent. This vegetation composition is indicative of highly modified peatland that has been subject to drying, agricultural improvement and grazing pressure, resulting in a transition towards rough grazing and semi-improved grassland habitats.

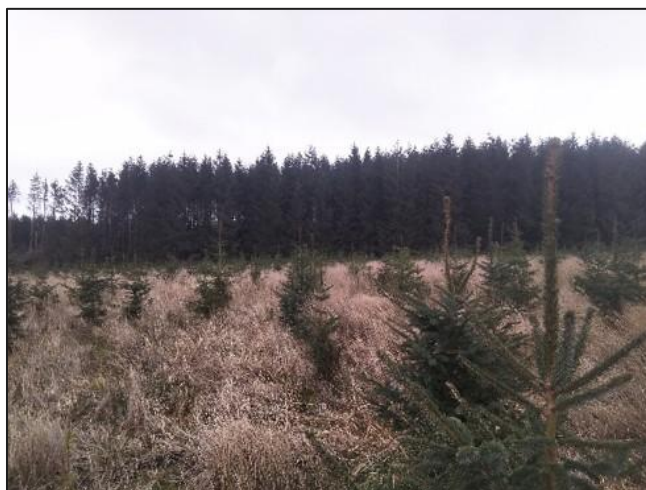
**Photograph 4-3 Mixed age forestry found on Site**

The field surveys also confirmed the distribution of woodland and forestry identified through the desk study. Commercial forestry occupies parts of the central-eastern area of the Site and includes plantations at varying stages of maturity, together with areas of recent restocking following historical felling. Smaller areas of natural and semi-natural woodland were also recorded in the northern and south-western parts of the Site. Overall, the field validation exercise confirmed the desk study findings that peatland habitats are limited, fragmented and generally in a modified condition, with the Site predominantly characterised by agricultural grassland and other non-peatland land uses.
